Archaeological Watching Brief, Electricity Switching Station
South Hill, St Helier

On Behalf Of
Jersey Electricity PLC

Results of an Archaeological Watching Brief

South Hill, St Helier

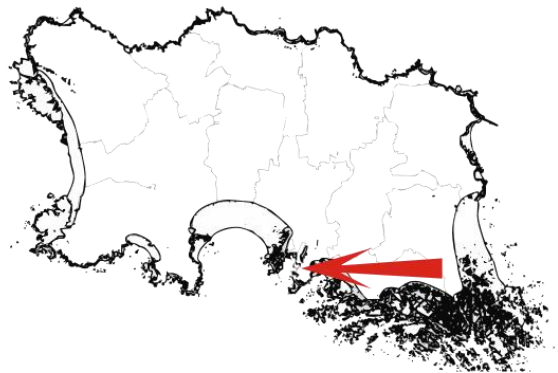
Figure 2: 1944 Aerial Photograph Centred on UTM 6512 4770

(Image 106WK 37.9.MAY.44.F/36''//541SQDN © Jersey Heritage Trust)

No evidence was found for the prison camp during the watching brief at South Hill. The position of the camp shown on the 1944 aerial photographs suggests that the main site of the development would only just encroach on the ESE side of one building and the SSW end of another (Figs 2-4). The camp would almost certainly have been at a level 2-3 metres down from the present ground level and positioned at the level of the 1910-1930 rubbish tip. It is suggested here that the camp would most likely have consisted of corrugated structures (or similarly easy to construct buildings) which would have been demolished soon after the end of the war, with materials reused. Any remaining foundations appear to have been razed to the ground or graded away, probably during the reuse of the site for landfill in the later period. The site has clearly been used for the deposition of landfill from the early 20th century, making use of a disused quarry site.

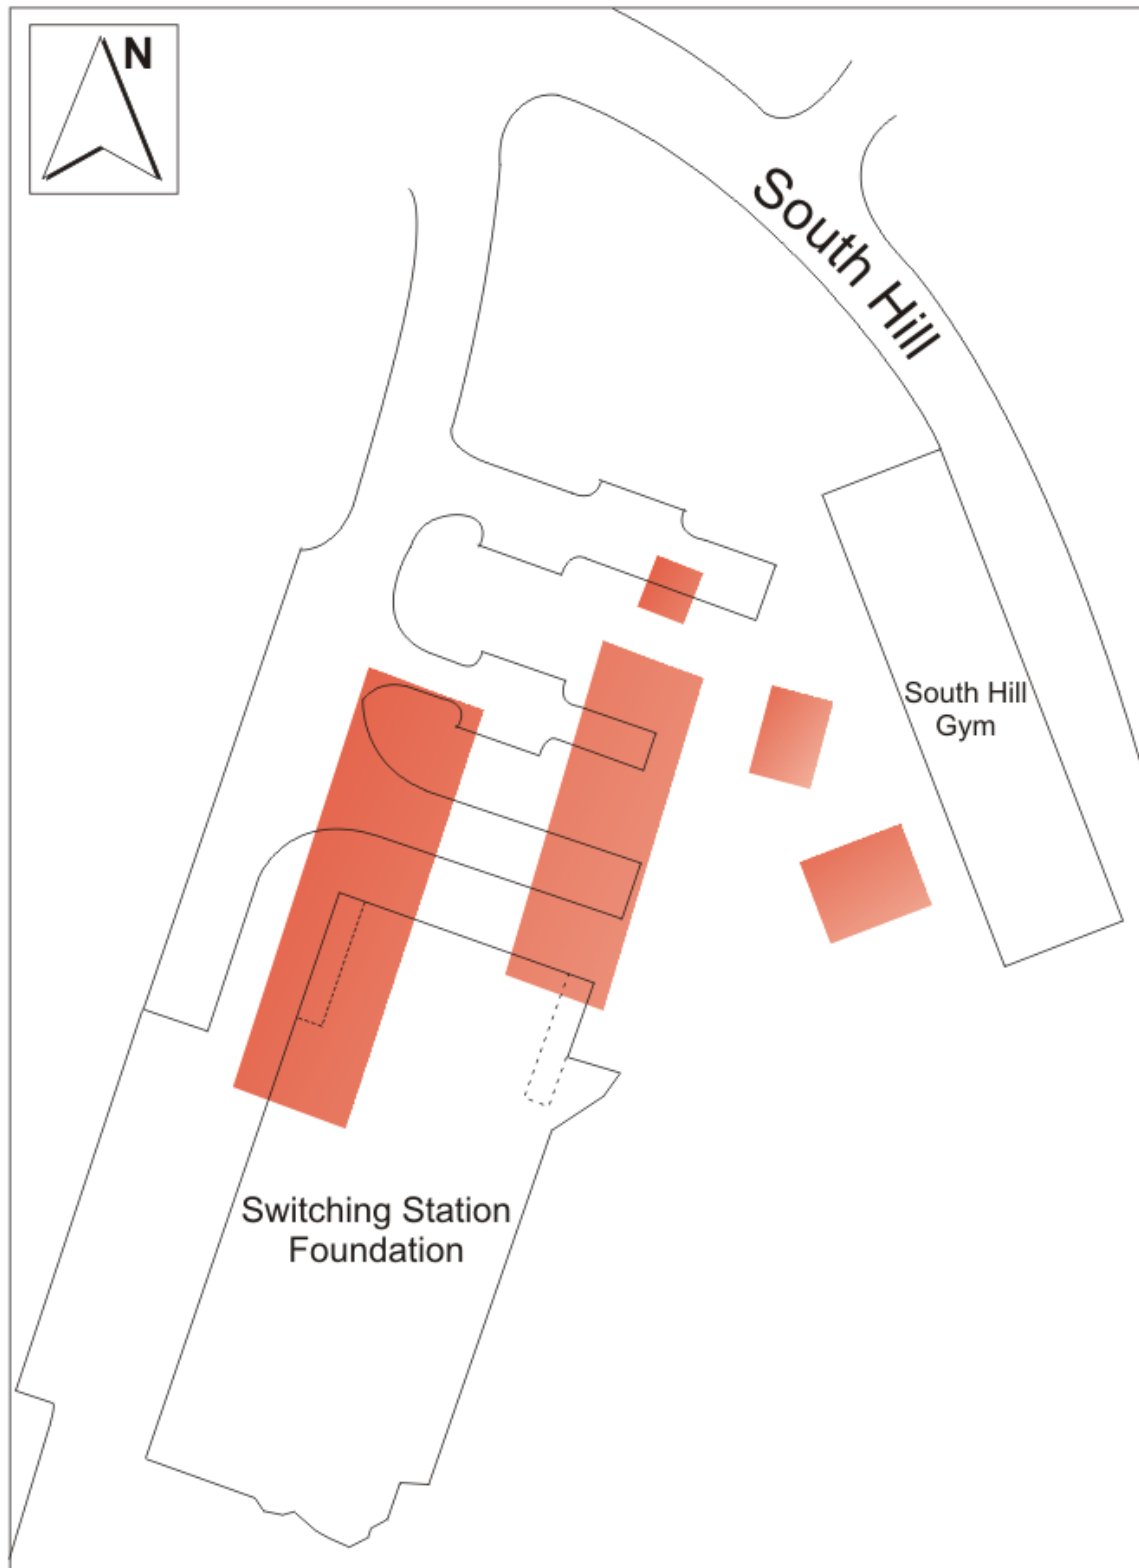
**Figure 4: Site Plan Showing Location of Development Overlaying POW Buildings
Scale 1:500**

= Location of 1944 Buildings Interpreted as POW Camp

= Location of Investigative Sondage
