Land Adjacent to  
3 Stonepail Cottages, Gatley,  
Archaeological Evaluation

## **Archaeological Test Pit Evaluation of Land Adjacent to 3 Stonepail Cottages, Styal Road, Gatley**

**NGR 384089 388284**

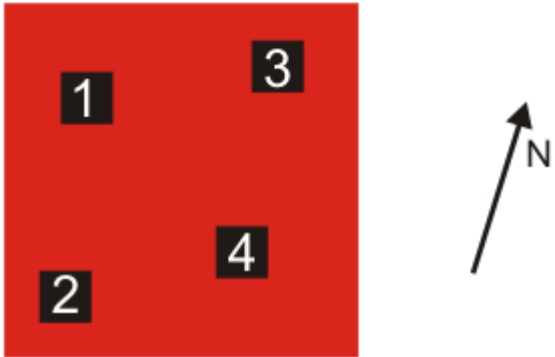
Figure 2: Test Pit Location

= Planned Location of Development

Detail: Location of Test Pits (1:150)

- 4.1 Test Pits 1, 2, 3, and 4 were positioned strategically to cover the groundworks for the proposed development. All Test Pits were located within the footprint of the foundations of the planned construction and orientated in line with the existing Stonepail Cottages. The sequence of soil layers in each pit was removed stratigraphically, by hand. All sections were cleaned and each test pit was recorded in plan with a representative section recorded to illustrate the sequence of layers. Each Test Pit is summarised below.

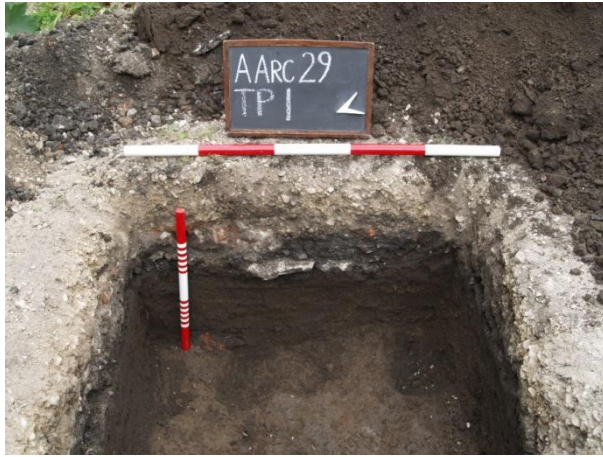
Photo 1: WSW Facing Section Test Pit 1  
Scales 1 x 1m & 1 x 500mm

Test Pit 1 measured 1 sq m x 600mm (d). A compact aggregate stone surface (100) for parking, to the north of the existing properties was removed to a depth of 150mm. This surface was seen to be overlying a hardcore surface (101), comprising loose broken stone, brick and industrial waste. As this layer was not present to the

south (nearer the existing cottages), it is interpreted as an earlier modern surface/path giving access to the yard to the rear of the properties. Beneath surfaces (100) and (101) was a humic garden soil (102). The layer comprised >300mm of very dark, yellowish brown (7.5YR 3/1 ) soft silty clay. The garden soil sealed a subsoil (103) comprising a medium yellowish brown soft silty clay (7.5YR 3/2). No archaeological features were noted, cut into the subsoil. An investigative sondage revealed the continuation of the subsoil to a depth >400mm. This layer was not bottomed.

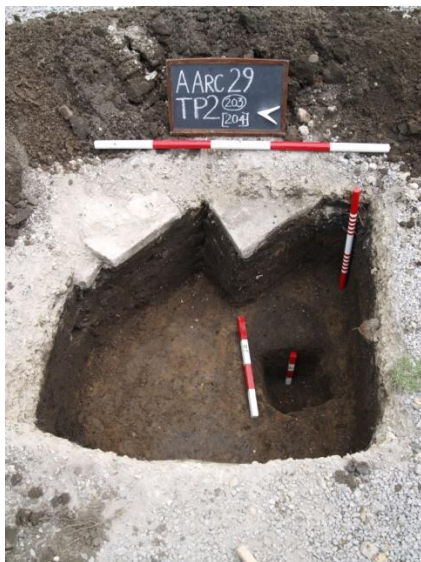
Photo 2: WSW Facing Section Test Pit 2 Showing Post Hole [204]  
Scales 1 x 1m, 1 x 500mm, 1 x 400mm & 1 x 200mm

Test Pit 2 measured 1 sq m x 500mm (d). The same compact aggregate stone surface (200) for parking, to the north of the existing properties was removed to a depth of 100mm. Two 20<sup>th</sup> century concrete in situ garden pavers [201] were revealed beneath the surface. The pavers were set into a buried turfline/topsoil (202). The turfline topsoil layer comprised 400mm of degraded turf (still visible) and a dark yellowish brown, silty clay garden soil. Although heavily abraded, 19<sup>th</sup> century ceramic sherds were found within the garden soil, the preserved nature of the turf and the fabric of the pavers would suggest that the garden was still in use in recent history. Layer (202) was seen to overlie subsoil (203), throughout all the trenches. In Test Pit 2, (203) was seen to be cut by a sub rectangular post hole [204], filled by the dark silty clay fill (203), representing a backfill of the garden soil above. The fill of the post hole contained further 19<sup>th</sup> century finds, however, these would have been deposited from the context used to backfill the pit.

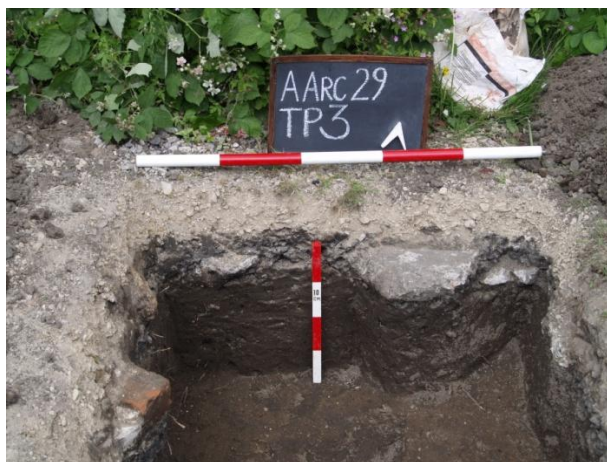
Photo 3: SSE Facing Section Test Pit 3  
Scales 1 x 1m & 1 x 400mm

Test Pit 3 measured 1 sq m x 620mm (d). The aggregate surface encountered in Test Pits 1 & 2, was recorded to a depth of 130mm, in Test Pit 3 (300). This was sealing a degraded tarmac and broken brick surface (301), similar to that observed in Test Pit 1 and probably representing an old access area to the garden area to the rear of 3 Stonepail Cottages. Small cast concrete paving stones [302] (>100mm l x >100mm w x 40mm d) were visible in the NNW and SSE facing sections and are interpreted as representing a 20<sup>th</sup> century garden feature. Beneath the pavers the dark yellowish silty clay garden soil was identified (303), the same as the layer recorded in Test Pits

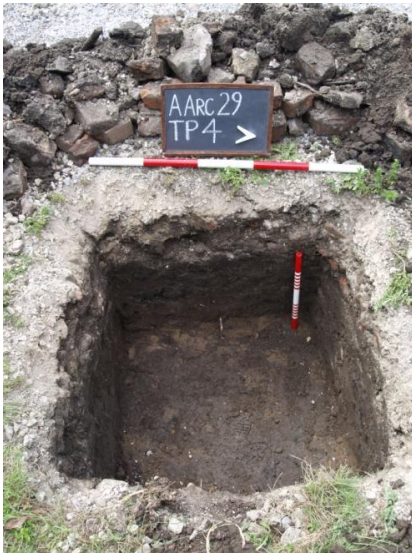
Photo 4: ENE Facing Section Test Pit 4  
Scales 1 x 1m & 1 x 500mm

Test Pit 4 measured 1 sq m x 800mm (d). The same sequence of layers was recorded in Test Pit 4, as in Test Pits 2 & 3. The aggregate surface (400) was recorded to a depth of 150mm and the hardcore surface (401) beneath was measured to a depth of 250mm. Topsoil (402) (400mm depth) and subsoil (403) were the same as those recorded in Test Pits 1, 2 & 3.
